Jul 10, 2015

John A. Weber, Hartford Steam Boiler Inspection & Insurance Co. | *Electrical Construction and Maintenance*

If you are like most facilities managers, you probably think busway is maintenance-free. There are no moving parts, so what could go wrong?

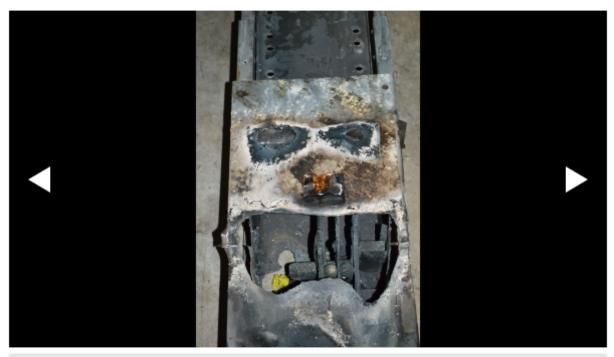
1 of 13

This 800A vertical busway section was installed in a multi-story apartment complex. A very distressed "face" was melted into the enclosure after this and other sections were involved in a major arcing ground fault event.

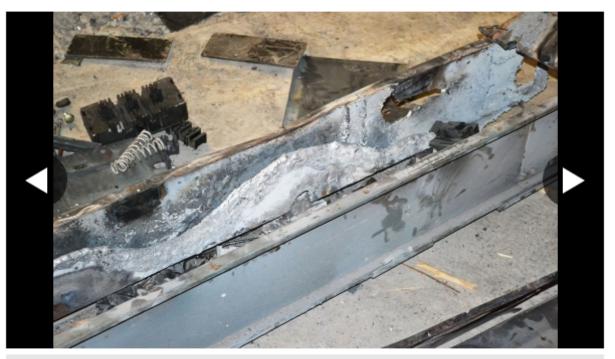
2 of 13

An 800A aluminum busbar is shown after the effects of an arcing ground fault. You can see the melting pattern of the ¼-in. aluminum bar. The arcing event destroyed multiple 10-ft sections that were vertically installed.

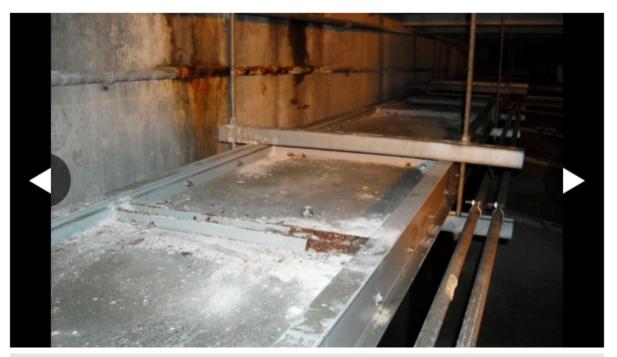
3 of 13

This busway failed due to the corrosive effects present in a parking garage. The road salt and poorly maintained floor joints allowed corrosive liquids to penetrate the busway enclosure. Busway joints are extremely vulnerable to arcing ground faults and shorts when salt water leaks into the splice joints. This type of damage can occur over many years of slow dripping onto the busway. Flat-wise busway runs are especially vulnerable due to the large exposed surface area. It is very hard to view and inspect this surface without the use of ladders.

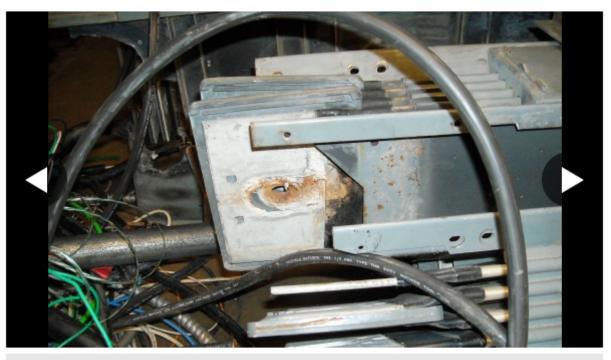
4 of 13

Liquids that enter the splice joints of the busway are especially prone to corrosion damage and joint failure. Although the busway eventually dried out after being contaminated, the corrosive effects continued.

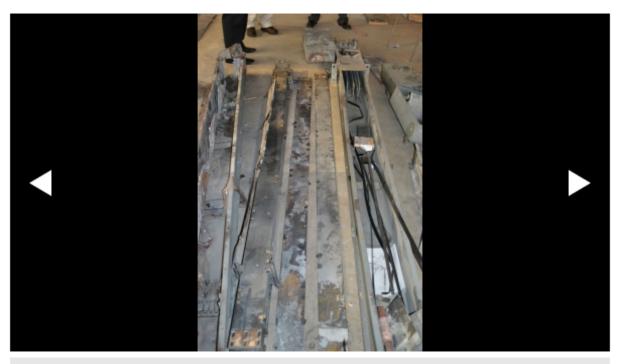
5 of 13

Multiple 10-ft sections of 800A busway were damaged after a catastrophic arcing ground fault event. Due to the age of the installation, the busway was no longer readily available. The failure of older busway sections sometimes requires replacement of the entire run due to product obsolescence.

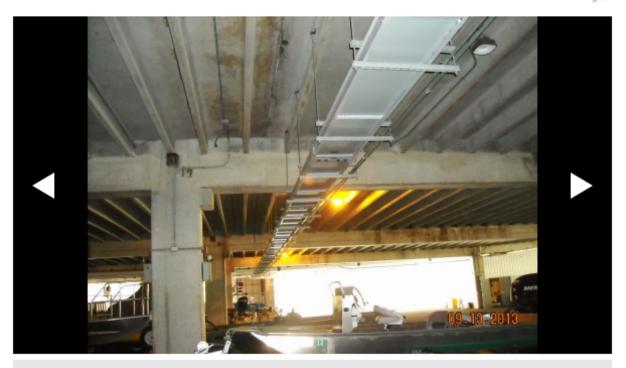
6 of 13

Poorly maintained parking garage floor joints will subject flat-wise busway installations to severe corrosion damage and failure. The busway often looks like new when viewed from the floor. When viewed on top while standing on a ladder, the extent of the corrosion damage is quickly evident. Does the routine maintenance for the busway include inspection of the top side of the busway enclosure?

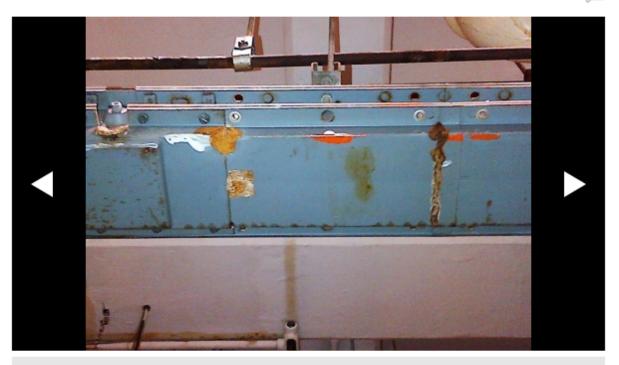
7 of 13

Slowly leaking overhead pipes or drains can contaminate busway over long periods of time. The drain above this emergency power busway has caused visible, severe corrosion of the busway enclosure. This busway is only energized during emergency power conditions. With this corrosion present, it is very likely that this busway will trip the overcurrent protective device at the moment it is critically needed.

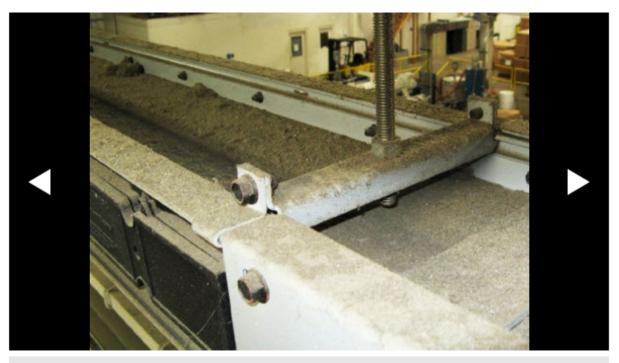
8 of 13

Failure to keep the busway enclosure clean can cause issues with overheating. Proper busway cleaning involves the use of vacuum cleaners and not compressed air. Compressed air can force particles into the enclosure/conductive busbar joints and cause internal damage.

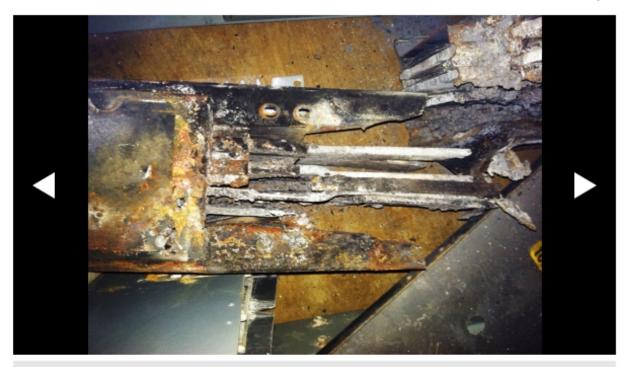
9 of 13

Busway is an NEC-defined raceway. Busway typically has conductor splice joints every 10 ft. Conduit and wire raceway systems typically run much longer lengths before splices occur. When designing high-reliability electrical distribution systems, consideration should be given to the difference in the number of the splice points along the raceway path. Each splice represents a higher probability raceway failure location.

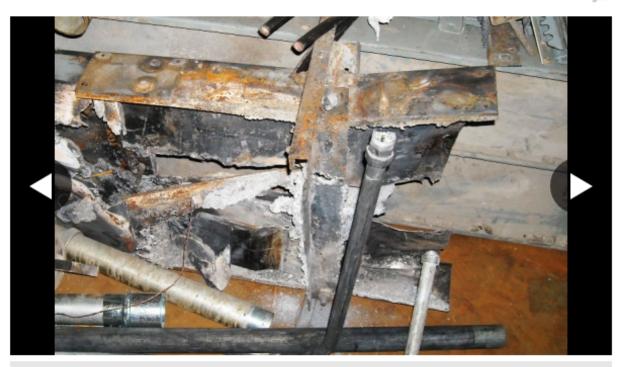
10 of 13

Arcing ground faults on busway are likely to be an amperage magnitude that is less than the trip-points of the overcurrent protective devices. Large amperage ratings of the busway OCPDs allow the fault to continue for significance lengths of time before the fault clears itself. Complete failure of the busway can occur, especially when no equipment ground fault protection devices are installed.

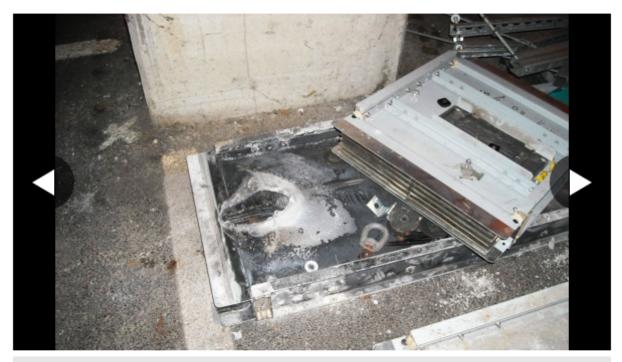
11 of 13

Leaking water with road-salt contamination in a parking garage floor entered this busway joint. The subsequent fault melted a hole completely through this busway. The hole is large enough to pass your hand through. All phases and the grounded enclosure were involved in this event. Periodic inspection of the parking garage floor joints and the busway would have prevented this disaster.

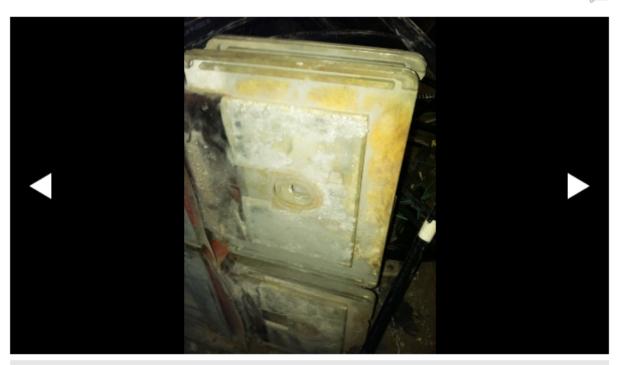
12 of 13

Arcing between the plate surfaces can occur due to loose connections or after water or other liquids enter the interstitial spaces. Although the liquids may eventually evaporate, the damage has already been done to the plate surfaces. This type of damage can increase the contact resistance of the joints and eventually cause overheating.

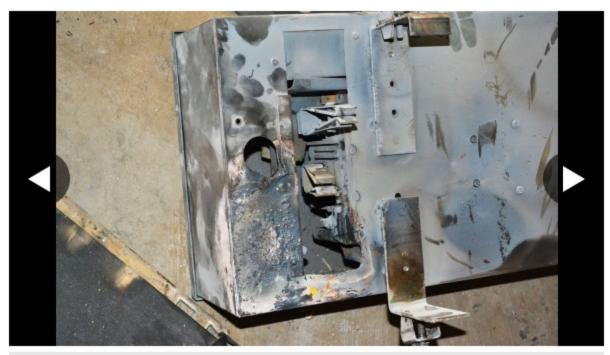
13 of 13

Although these connections are located behind the busway switch, infrared thermography might have seen this impending failure before this damage caused a building outage. A possible loose connection screw could have been repaired before any heat damage occurred to the electrically conductive parts.
